Fondation Eagle

Report Form

Additional Retaining Wall and Replacement of Centre Exterior Wall, Tea Leaf Centre Maskeliya, Upcot Road, Maskeliya, Central Province, Sri Lanka

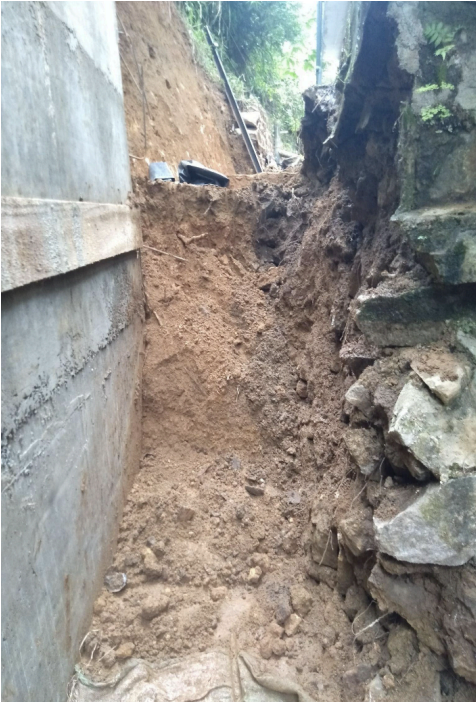
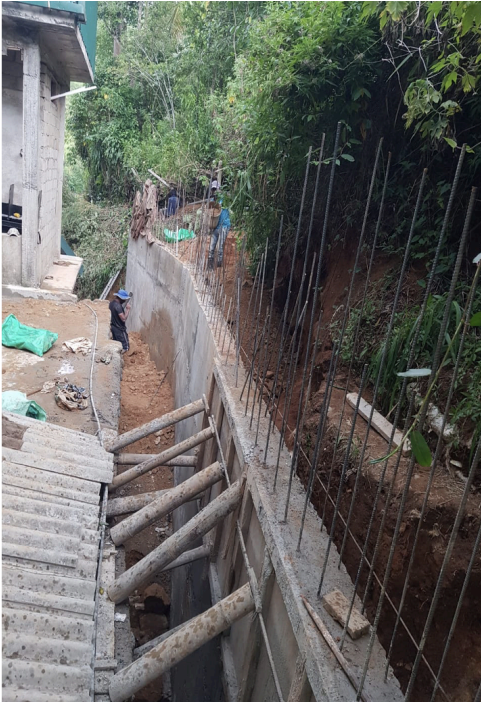
Before:

The project involved constructing an additional section of the retaining wall and replacing an existing unstable wall made of stones and mud to ensure the safety and usability of the adjacent rooms. This was essential due to the risk of landslides and structural instability, which posed a threat to the school building.

| Aspect | Before the Project | After the Project | Impact |
|---|--|--|---|
| Wall Condition | Unstable stone and mud walls were prone to collapse. The retaining wall did not cover all vulnerable spaces. | Durable cement block wall with plastering | Increased structural integrity, ensuring safety for users and protecting the building |

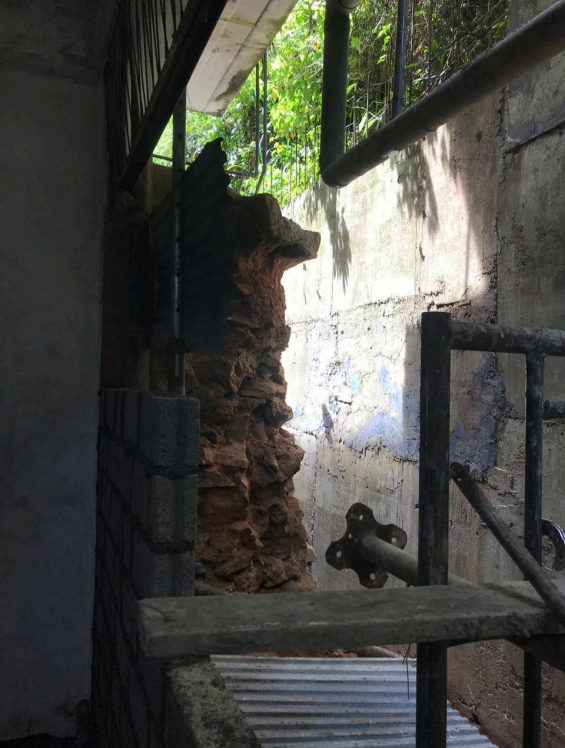
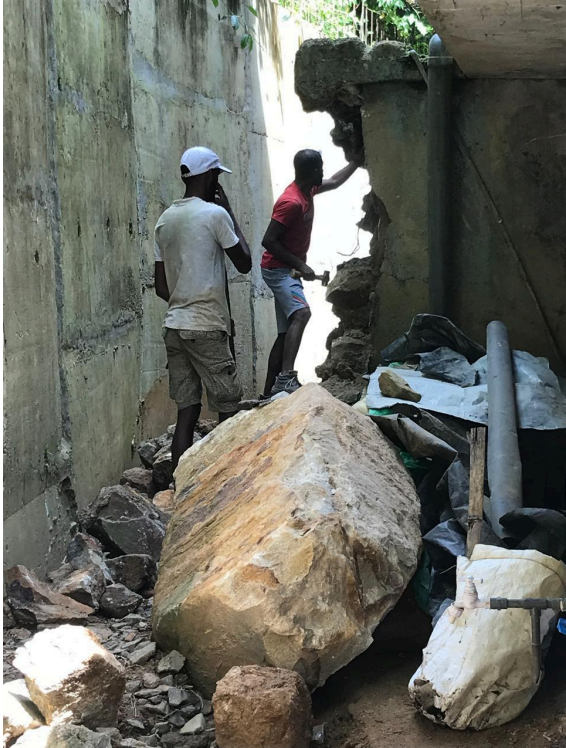
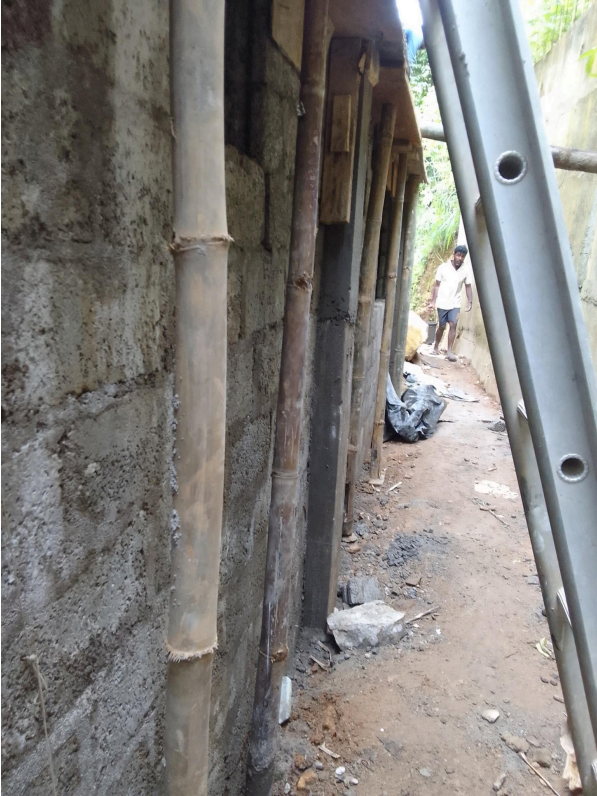
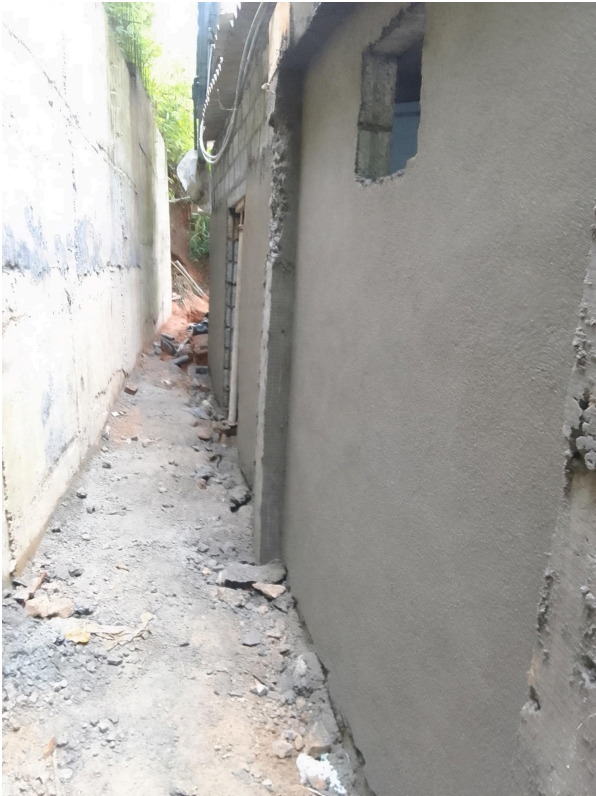
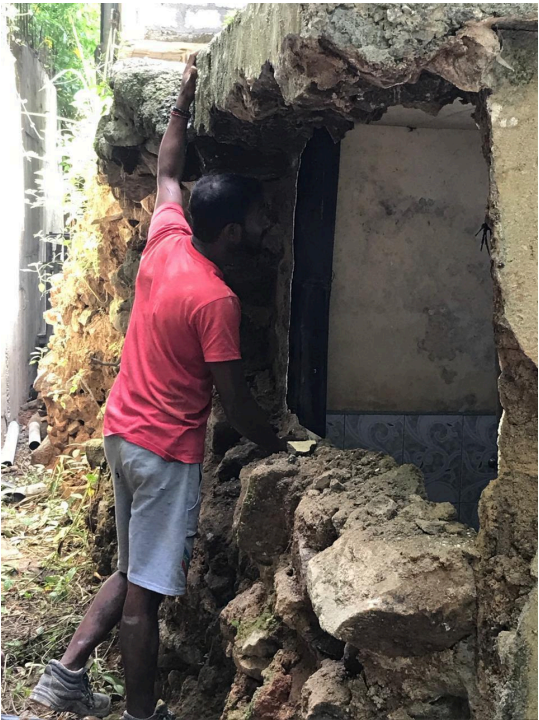
During:

A new 8 x 12 feet section was added to the right-hand side of the previously funded retaining wall to cover a wider area affected by landslides. Temporary support structures were used during construction to secure the earth and allow safe working conditions. The wall height was increased as

an additional safety measure, and a new cement block wall was constructed behind the school after discovering inadequate prior construction consisting of only rocks and mud.

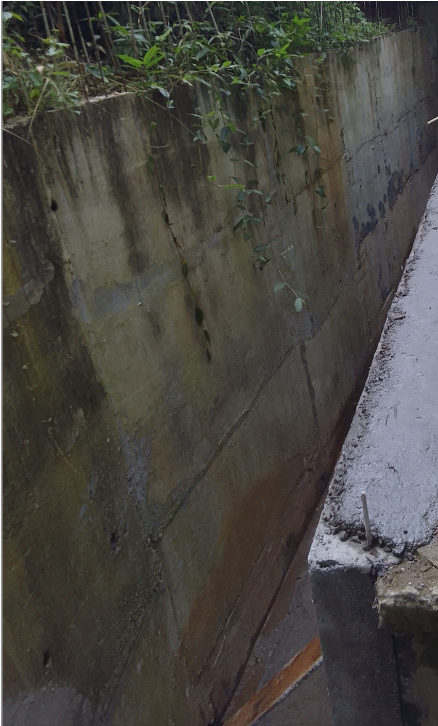
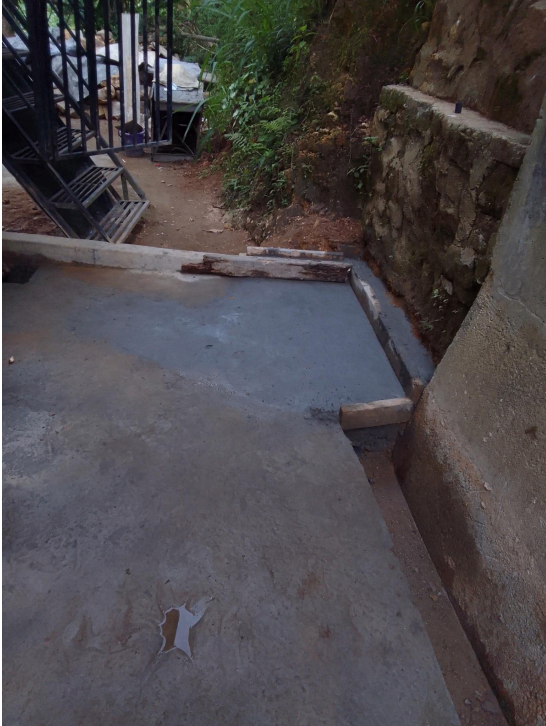
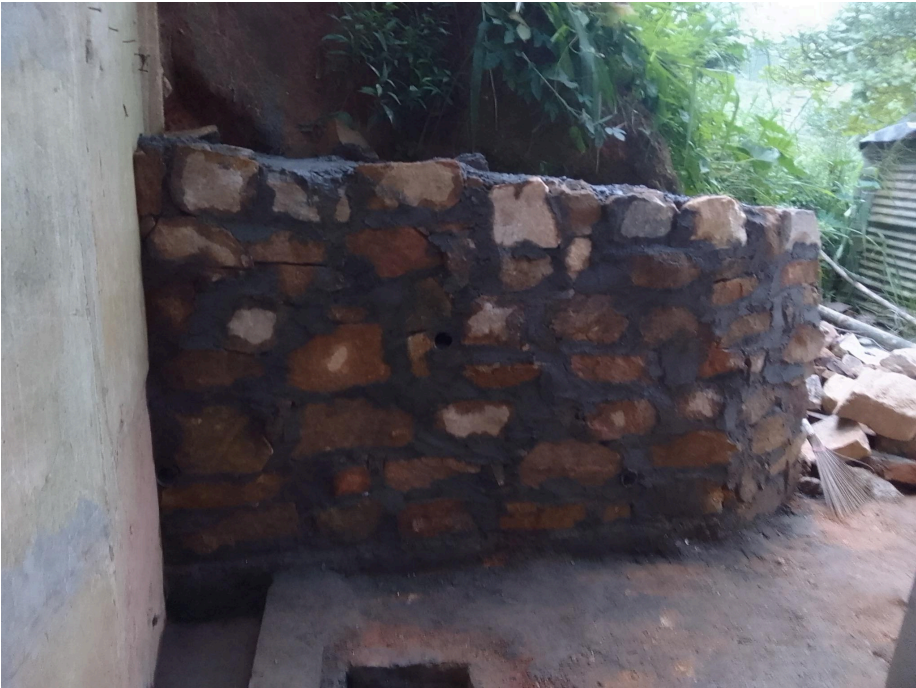
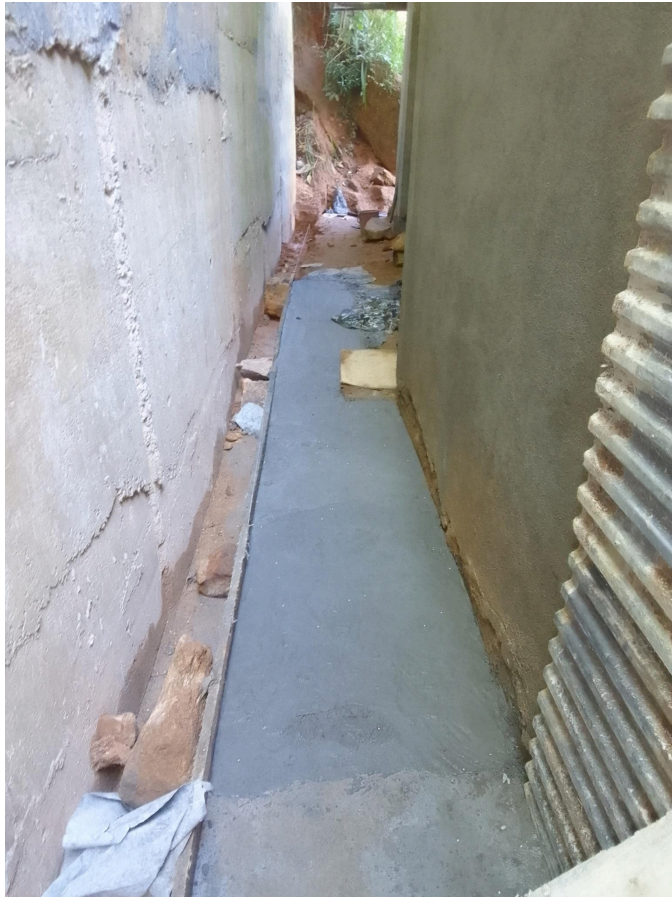
After:

Follow up: The wall is now finished as is the back wall of the centre building. We will unblock the drainage holes and ensure that we check regularly for cracks etc.
